# **Pentium® II Processor Specification Update**

Release Date: July 1999

Order Number: 243337-028

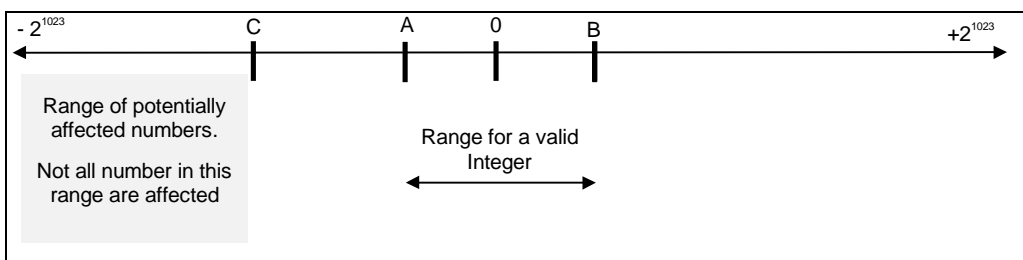
**IMPLICATION:** Erroneous operation results when the operand is so large that it will not fit into the target data size. The operands affected by this erratum are significantly outside (by a factor of 3X) the range that can be, correctly, converted to an integer value. The figure below and corresponding table identifies the normal range of integer numbers (between A and B) and the starting point of the operands affected by this erratum. Discrete failing operands will be present in the range between point C and the maximum negative number that can be represented by the processor ( $-2^{1023}$  in double precision format). Note 2 below gives a qualitative description of the nature of the discrete failing values. Software that does not rely on the Invalid Operation exception flag being set and signaled by either an exception OR by software polling is not impacted by this erratum.

16-bit Operation	A	B	C
	-32,768.0	+32,767.0	< -98304.0
32-bit Operation	A	B	C
	-2,147,483,648.0	+2,147,483,647.0	< -6,442,450,944.0

**WORKAROUND:** Any of two software workarounds will avoid occurrence of this erratum:

1. Range checking performed prior to execution of the FIST[P] instruction will prevent the overflow condition from occurring, and may already be implemented as a coding style.
2. Software can use the presence of MAXNEG in the result integer to indicate that an out of range conversion may have occurred.
